The Role of Landscape Design in Pedestrian Movement within the Caleb University Campus, Imota, Lagos State

Olasunbo O. Ademakinwa¹, Divine-Favour O. Azuka², Oluwademilade Ogunberu³, Chinwe Okonkwo-Eje⁴ & Abosede O. Akindele⁵

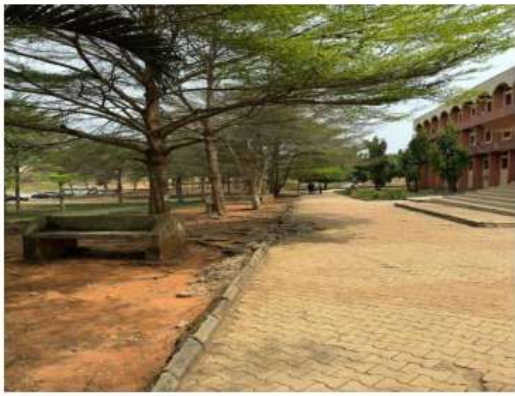
Plate 3: Academic core path — mature canopy overhead, concrete bench, eroded drainage edge

The paths flanking the main academic buildings represent the campus zone with the strongest existing shade provision. Mature trees—predominantly *Albizia* and related species—provide generous canopy cover over the interlocking block pathway beside the building facade, creating a shaded pedestrian corridor that is perceptibly more comfortable during peak solar hours than the entry corridor. A concrete bench is present in this zone, providing a rare example of formal seating provision on the campus.

However, the zone also presents a significant landscape failure in the form of a deteriorating drainage channel running between the path edge and the tree zone. The channel is eroded, with exposed soil, displaced tree roots, and debris visible along its length. The edge between the paving and the drainage channel is poorly defined, presenting a potential trip hazard.

6. **Seating and Rest Facilities:** The single concrete bench documented in the academic core path area (Plate 3) is the only formal seating provision observed across all six assessed route segments. A programme of shaded seating installation at key nodes — academic building approaches, path junctions, and the chapel approach — would directly address the comfort and optional activity deficiencies identified by Atolagbe et al. (2025) and Gehl (2010) as consequences of inadequate outdoor amenity provision.

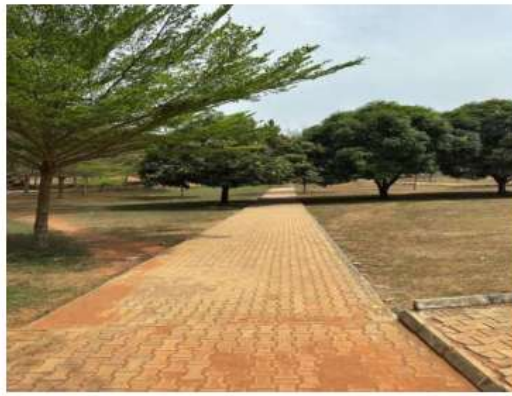
Plate 4: Secondary path through tree grove — partial shade, stained paving, absent edge definition

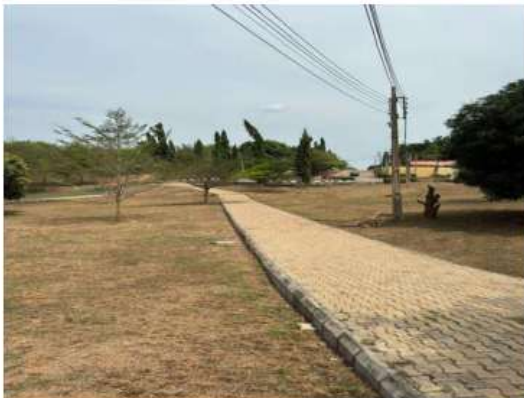
The main entry corridor — connecting the campus gate to the central academic zone — is the busiest single pedestrian route on the campus. The corridor is surfaced with interlocking concrete block paving and presents a generally intact surface structure. However, the corridor is characterised by a near-total absence of shade canopy. The trees planted along both sides of the path are young and immature, providing no meaningful overhead shade cover during peak solar hours.

The surrounding ground is dry, sparse grass with low vegetation density, confirming the Harmattan-period conditions of the observation. This condition directly contravenes Adunola's (2014) benchmark of 50% canopy cover for thermally acceptable tropical pedestrian environments, and is consistent with Atolagbe et al.'s (2025) finding that inadequate shading is a primary landscape performance deficit at south-western Nigerian university campuses.

Plate 1: Main entry corridor — intact paving, absent shade canopy (looking north)

1. Shade Tree Planting Programme: Initiate an immediate programme of shade tree planting along the full length of the main entry corridor (Route 1) and the academic open court zone (Route 5),

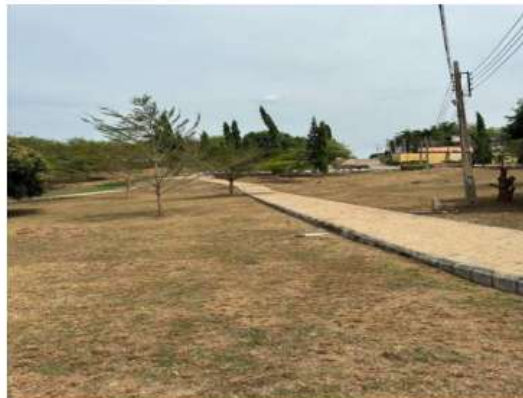
Plate 2: Main entry corridor — reverse view showing sparse young trees and open exposure

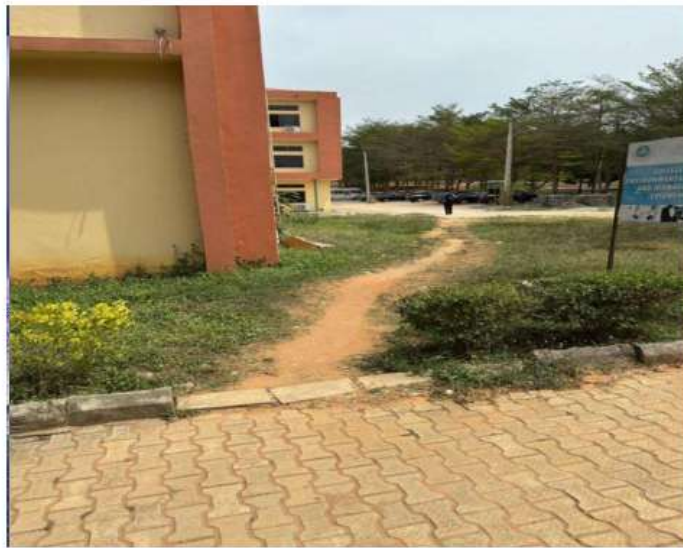
The most unambiguous evidence of landscape design failure documented in this study is the desire line recorded at the approach to the COLENSMA building. A clearly worn laterite track — approximately 0.5 metres wide at its narrowest point — cuts diagonally across a planted grass area between the building corner and the car park area, bypassing the formal paved path. The desire line is stabilised, meaning it has been in use long enough for the soil surface to be compacted and for all ground cover vegetation to be suppressed along its route. A pedestrian is visible actively using the desire line in the photographic record.

The COLENSMA signboard is visible in the background, confirming the location. This desire line is a direct spatial vote, in the terms used by Adebara et al. (2022), against a formal path layout that fails to serve the actual movement trajectory between the building entrance and the car park. It represents a clear design signal that the pathway network requires redesign at this node to align with users' natural movement preferences.

Plate 5: COLENSMA building approach — stabilised desire line cutting diagonally across planted area

4. **Desire Line Formalisation at COLENSMA Approach:** The active desire line documented at the COLENSMA building approach should be formally incorporated into the pathway network by the construction of a properly surfaced, edge-defined path along the desire line's alignment. This approach — formalising rather than blocking informal routes — is supported by Adebara et al. (2022), who demonstrated that informal pedestrian movement is a spatial response to formal provision failure that is most effectively addressed by closing the provision gap rather than by punitive measures.

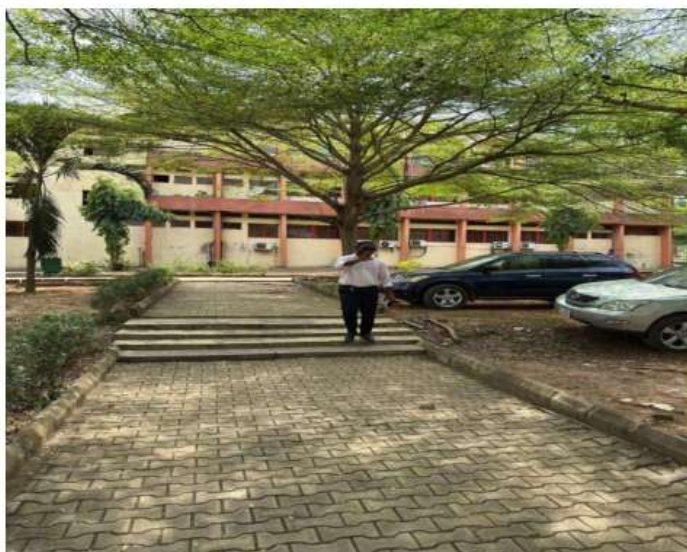
Several of the campus's academic buildings are accessed via stepped platforms that interrupt the continuity of the interlocking block pathway system. The steps are constructed in concrete with interlocking block risers, and are generally intact in structural terms.

However, vehicles are parked immediately adjacent to the pedestrian approach zone in several locations, creating a conflict between vehicular and pedestrian movement that reduces the effective usable width of the approach path and increases the exposure of pedestrians to vehicle-related hazard. The tree canopy overhead in this zone is good, providing adequate shade, but the spatial organisation of the transition between path, steps, and vehicle access is poorly defined, reducing the legibility of the pedestrian route at this critical building-approach junction. Odeyale (2022) specifically identified legibility and coherence at building-approach junctions as a primary determinant of user satisfaction with campus pedestrian environments.

Plate 6: Academic building approach — stepped path with vehicle parking conflict and good overhead canopy

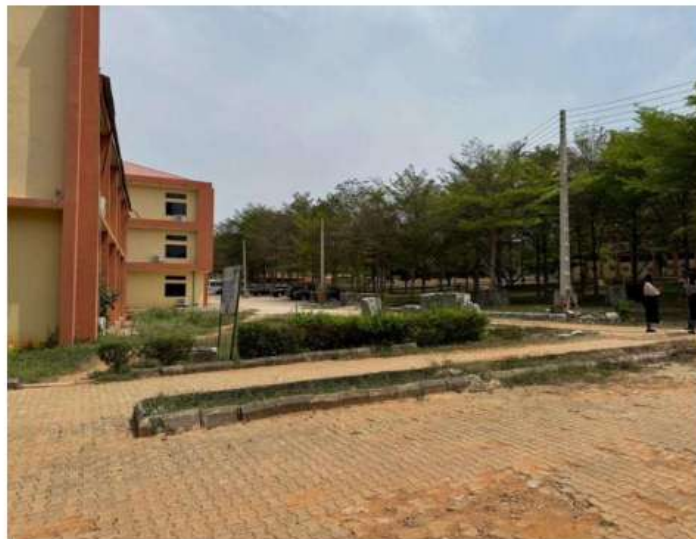
The open court area between academic building blocks presents the most spatially legible evidence of incomplete formal pathway provision. The interlocking block paving terminates abruptly, with a broad expanse of bare laterite soil beyond — a zone through which pedestrians are observed moving directly, in the absence of any formal path surface.

Broken kerb edging is visible, with displaced blocks and exposed subgrade, indicating both construction incompleteness and early-stage degradation. The vegetated planting beds in this zone show evidence of routine maintenance (trimmed low hedges) but are not integrated with a functional pedestrian route system. This condition — formal paving ending mid-campus, requiring users to cross bare soil to reach their destinations — is precisely the type of path network discontinuity that Pikora et al. (2003) and Southworth (2005) identify as a primary generator of informal path creation.

Plate 7: Academic court — paving terminating abruptly, large unpaved laterite zone, broken kerb edges

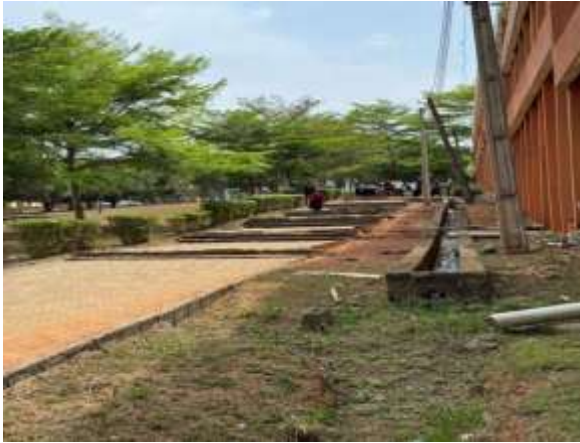
The stepped pathway running alongside the main academic block represents the most critically compromised pedestrian route documented in this study. This route is in active daily use — multiple pedestrians are visible in both photographic records — yet the landscape conditions along its entire length are severely degraded. The concrete drainage channel running between the path and the building face has partially collapsed, with stagnant water visible, displaced concrete blocks, and exposed subgrade soil along extended sections of the channel.

The stepped path surface itself shows significant erosion of the joints between treads, with laterite soil washed out from beneath the concrete, creating an uneven and increasingly unstable walking surface. Construction debris — pipes, broken blocks, timber — is scattered along the route. The combination of active stagnant drainage, surface degradation, and debris constitutes a significant pedestrian safety hazard. Adeyemi (2013) identified waterlogging and surface degradation as the most significant deterrents to walking in West African environments; the conditions documented here represent an acute manifestation of this problem.

Plate 8: Stepped path beside academic block — stagnant drainage channel, eroded steps, debris

2. **Drainage Channel Rehabilitation:** The collapsed and stagnant drainage channel alongside the stepped academic building path (Route 6) must be treated as an emergency infrastructure priority. Rehabilitation should include the reconstruction of the channel with adequate fall to prevent ponding, the installation of channel covers or grilles over the most heavily used pedestrian crossing points, and the establishment of a maintenance programme for annual channel clearance before the wet season.

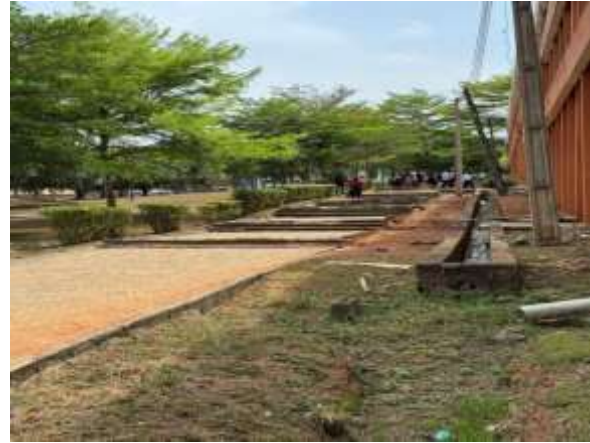
Plate 9: Same route from above — paving intact (left) but drainage channel collapsed (right), pedestrians in use

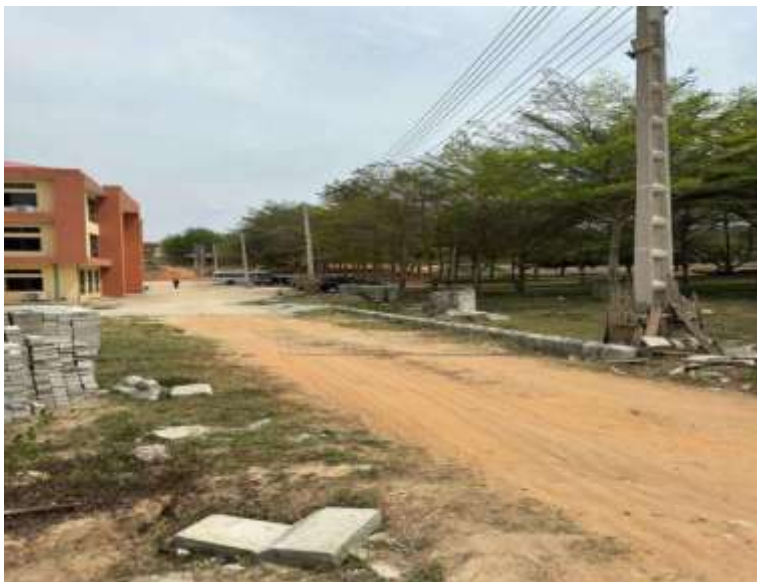
An extended zone adjacent to one of the academic building blocks presents an entirely unpaved laterite surface. Paving blocks are stacked in organised piles nearby—indicating that paving installation is planned or in progress—but the current surface condition is bare compacted laterite with no edge definition, drainage provision, or planting. A single pedestrian is visible using this route.

This zone represents an example of incomplete campus infrastructure where the absence of formal pathway provision is creating compacted laterite desire lines that will become progressively more difficult to rehabilitate. As Harmattan dust accumulates and wet-season rainfall erodes the exposed surface, these informal tracks harden into permanent features, increasing future remediation costs and safety risks.

Plate 10: Unpaved zone beside academic building — bare laterite, stacked paving blocks awaiting installation

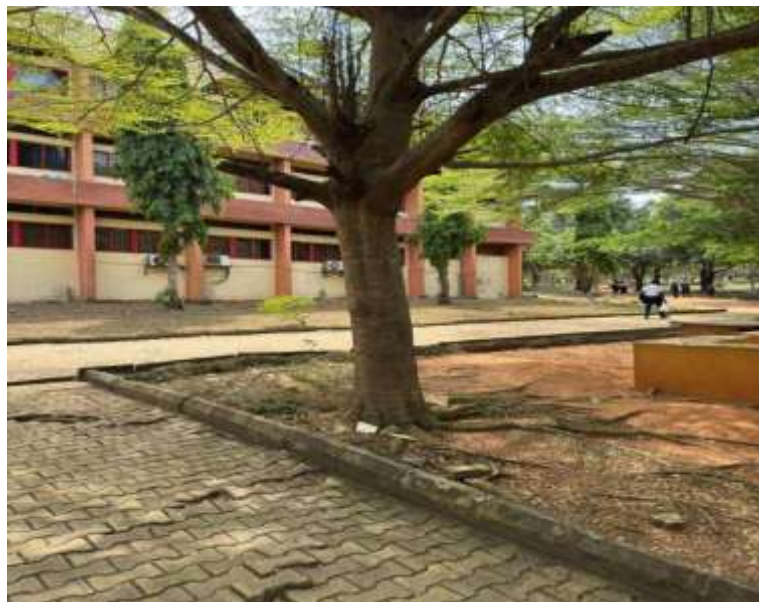
A particularly significant form of paving failure is documented at one location in the academic core, where a large mature tree has been allowed to grow in direct proximity to the interlocking block pathway without root management provision. The surface roots of the tree have heaved the paving blocks significantly, displacing and fracturing them over a zone of approximately 3–4 square metres. This condition creates a serious trip hazard directly on the pedestrian route.

The failure reflects a design decision—or absence of design decision—in which tree planting was carried out without root barriers or sufficient setback from the path edge, resulting in a conflict between the landscape and the infrastructure that will worsen progressively as the tree matures. Without intervention, ongoing root expansion will continue to destabilize the pedestrian surface, eventually requiring full pathway reconstruction.

Plate 11: Tree root uplift displacing and fracturing interlocking paving blocks — trip hazard on active pedestrian route

5. **Root Barrier Installation and Tree Setback Policy:** The installation of root barriers during all future tree planting adjacent to paved surfaces should be adopted as a campus standard. Where existing trees are already causing paving uplift, a decision framework should be established to determine whether root-cutting, root barriers, or tree removal and path realignment is the most appropriate response on a case-by-case basis.

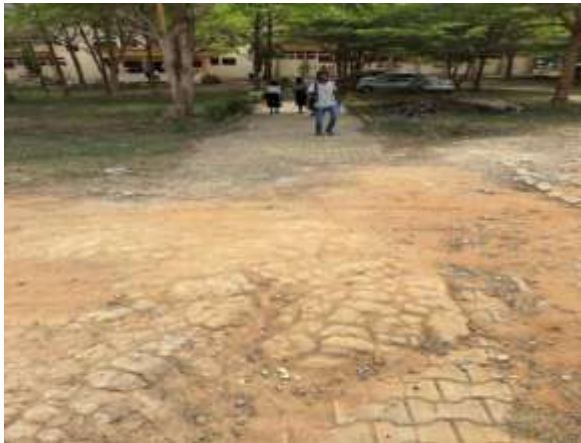
Two locations document the most advanced stages of paving failure recorded in this study. At one location, the interlocking block surface has been almost entirely consumed by laterite soil encroachment — blocks are visible beneath the surface as raised mounds, but the effective walking surface is now bare compacted laterite with scattered debris. Pedestrians are walking directly on the degraded surface. At the most critically deteriorated location, adjacent to an academic building, the paving has collapsed entirely across a wide zone: blocks are broken, scattered, and partially buried; steps are crumbling; the sub-base is exposed; and construction materials lie across the pedestrian zone. This location represents the complete failure of the original pedestrian surface investment and presents the highest immediate safety risk of any zone documented in the study.

Plate 12: Severe paving degradation — blocks buried under laterite, pedestrians on bare soil surface

3. **Paving Repair and Completion:** The severely degraded paving zones identified in Plates 12 and 13 require immediate surface reinstatement. Sections where paving has been consumed by laterite encroachment should be re-laid with new interlocking blocks on a properly prepared sub-base. The unpaved construction zone (Route 6, Plate 10) should be prioritised for completion before the onset of the wet season, preventing the escalation of laterite erosion on the exposed surface.

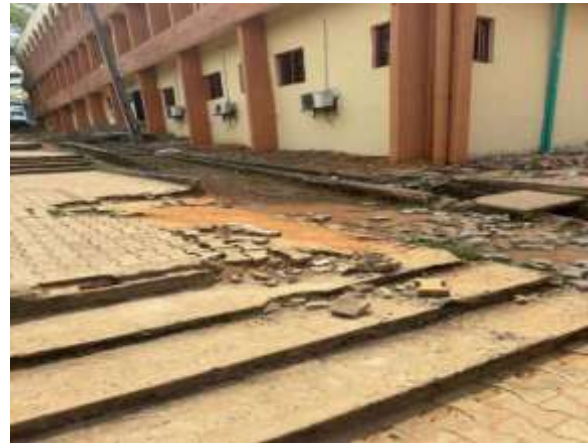
Plate 13: Complete paving collapse beside academic building — broken blocks, exposed subbase, crumbling steps
