**Assessment of Measures and Procedures in Mitigating Fire Outbreaks in Commercial Buildings in Lagos Island, Lagos Nigeria**

**Ajibola V. Ogunojemite<sup>1</sup>, Christian T. Odefadehan<sup>2</sup> & Oluwatoromo O. Akinyemi<sup>3</sup>**

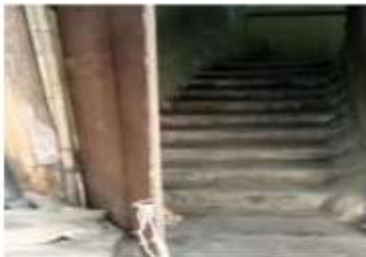
Stairwell 1

Field observations revealed the wide spread use of narrow staircases in mid-rise mixed-use buildings on Lagos Island.

In several cases, a single stairway of inadequate width, served multiple floors and mixed occupancy. Such stair configurations fall short of established fire-safety principles which require adequately sized and protected means of escape proportional to occupant load and building height. During fire incidents, these narrow staircases are prone to congestion and rapid smoke infiltration, thereby, increasing evacuation time and enabling fire incidents to morph into major outbreaks. Furthermore, the staircases observed, reveal that many buildings have inadequately-sized and unprotected stairwells that typically open to adjoining commercial spaces and lack fire-rated enclosures or doors, thus, allowing smoke and heat to rapidly infiltrate escape routes during fire incidents, As a result, stairways intended for evacuation may become unusable at early stages of a fire, significantly increasing evacuation difficulty and contributing to the escalation of fire incidents into large-scale outbreaks.

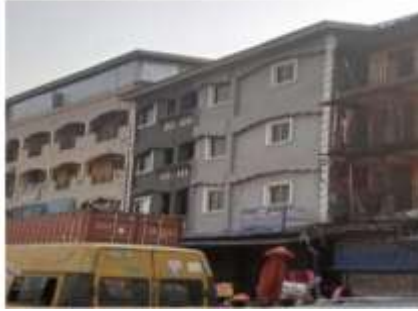
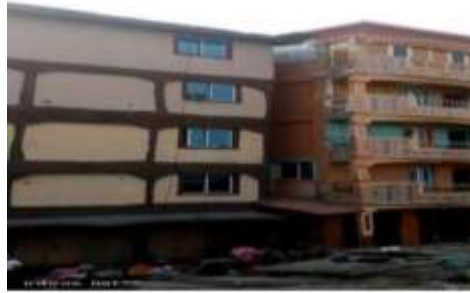
Field observations showed several instances where originally distinct commercial buildings had become physically joined through informal extensions and shared structural elements.

*Conjoined buildings on Nnamdi Azikiwe Street, Lagos Island*

The absence of fire-rated separation walls and minimum spacing between buildings eliminates horizontal fire containment, allowing fires to spread rapidly from one structure to another. Such conditions undermine the fundamental principle of compartmentation at both building and urban scales and significantly contribute to the escalation of isolated fire incidents into large-scale fire outbreaks on Lagos Island. In other words, on Lagos Island, fire outbreaks are not merely building failures but block-level architectural failures caused by the erosion of fire separation between adjacent properties

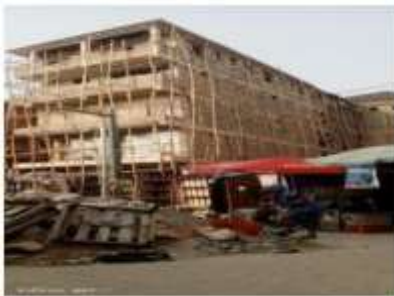
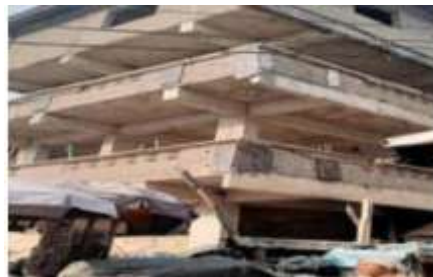
Field observations revealed that some commercial and mixed use buildings under construction or nearing completion, lacked viable active fire protection systems such as sprinklers or hose reels.

*Ongoing buildings under construction along Kosoko street, Lagos Island*

This indicates that fire safety considerations are often omitted at the design and construction stages, rather than being solely a legacy issue of older buildings. The absence of these systems in new developments suggests weaknesses in regulatory enforcement, professional practice and approval processes, thereby perpetuating conditions that allow fire-incidents to escalate into fire outbreaks. Fires start small and with no suppressants, it grows rapidly and coupled with buildings joined at the seams and narrow unprotected stairwells, a fire outbreak occurs. In other words, the absence of active fire protection systems in newly-constructed commercial buildings demonstrates that fire risk on Lagos Island is not merely inherited but continuously regenerated through design and regulatory failures. Furthermore, field observations indicate that many commercial buildings on Lagos Island are constructed using hollow block masonry walls and reinforced concrete structural frames which are inherently non-combustible and provide a degree of passive fire resistance.

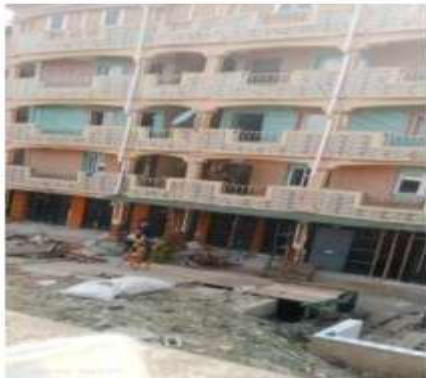
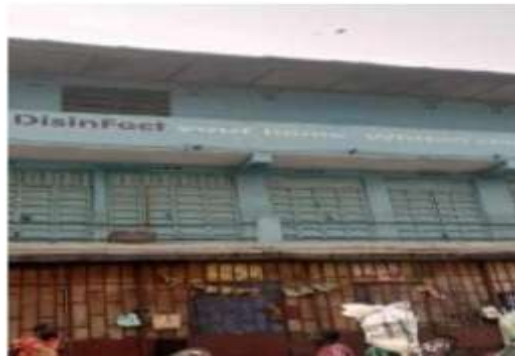
Field observations here revealed widespread use of metal security doors as the primary access point to commercial shops on Lagos Island. Welded steel plate doors, roll-down metal shutters or locally-fabricated iron doors are used based on the assumption that they are fire-rated because they are made of metal primarily for security

### *Mixed-use buildings on Lagos Island*

While steel doors are non-combustible and may offer some resistance to fire spread, their use as the sole means of escape raises significant life-safety concerns. In the event of a fire, heat-induced deformation, smoke accumulation or locked shutters can impede occupant evacuation, increasing the likelihood of fatalities before fire outbreaks are externally contained. . Furthermore, despite being metallic, the doors lack fire-rating certification, intumescent seals and self-closing mechanisms, rendering it ineffective as a fire-resistant barrier (Vtrotech (2025))

The prioritization of security over fire-rated egress design reflects a critical gap in architectural safe planning. Security-driven shopfront designs, when unaccompanied by secondary escape routes or fire-rated doors, can transform non-combustible elements into life-threatening barriers during fire incidents

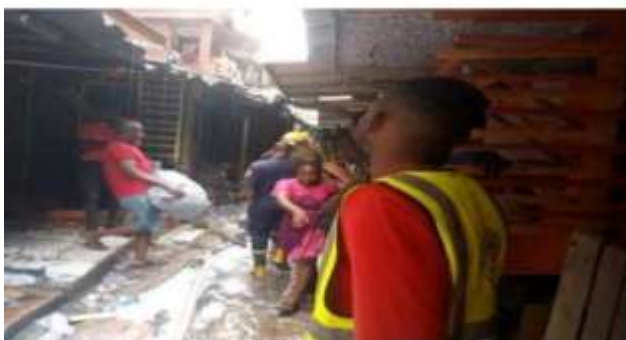
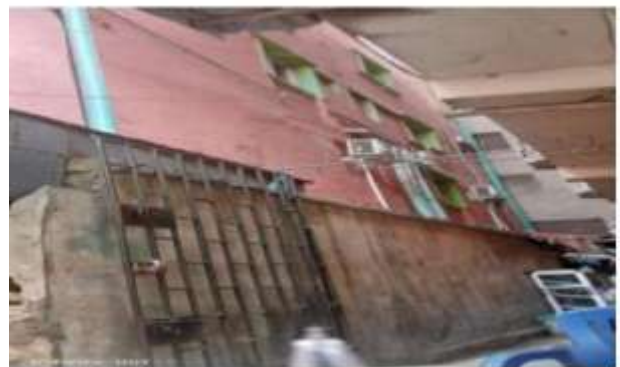
Field observations revealed that many commercial buildings on Lagos Island lack secondary fire exits, relying solely on a single shopfront entrance for occupant escape in case of fire incidents.

### *Narrow streets with shopfronts opening into them Back of building along Nnamdi Azikiwe street*

This configuration contravenes international best practice, which recommends multiple independent means of egress for commercial occupancy. In the event of a fire, the absence of alternative escape routes increases evacuation time, heightens panic and elevates the risk of fatalities, thereby, allowing otherwise manageable fire incidents to escalate into major fire outbreaks. The absence of secondary exits represents one of the most direct architectural pathways through which fire incidents on Lagos Island escalate into large-scale outbreaks

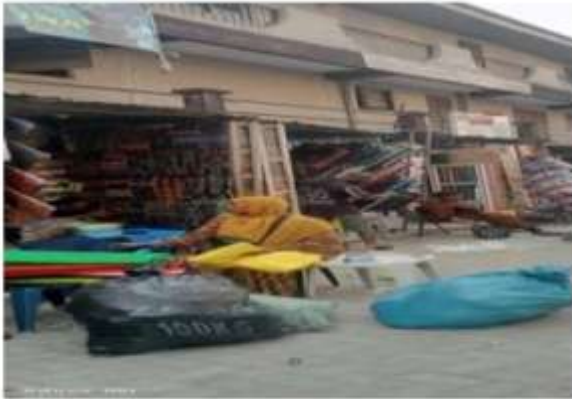
Field observations equally reveal the the extensive use of PVC ceiling panels and timber wall finishes within several commercial shops on Lagos Island. These materials significantly increase internal fire load and smoke production, thereby accelerating fire growth and reducing safe evacuation time in the event of ignition

*Shops along Kosoko street*

- a) The use of combustible interior finishes such as PVC panels and untreated timber should be minimized with preference given to materials with certified fire resistance and low smoke toxicity
- b) Facade systems including aluminum composite panels, should be subjected to rigorous fire performance assessment, and only non-combustible or fire-rated systems should be approved for commercial buildings
- c) Openings, doors and service penetrations within fire-rated elements, should be detailed and constructed to preserve compartment integrity
